The Cockleshell Pit Stop

2008

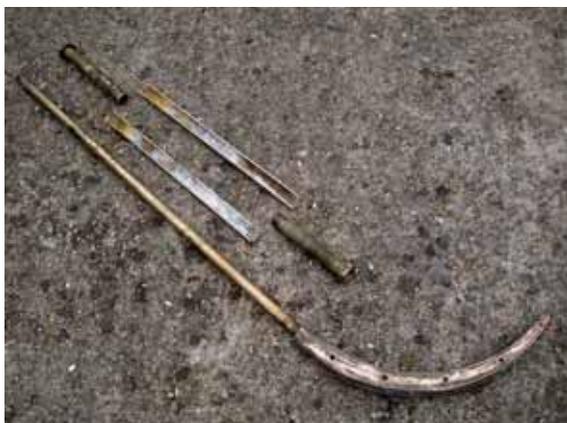
first time in the workshop at Beauregard. The new mahogany rudder blade that your author built had been lovingly fashioned using the old one as a pattern, and after a coat of SP epoxy was offered up and rivetted back into the original bronze stock. So now with rudder and stock out of the boat for the second time the job of driving the rudder tube off the stock was next, but no amount of heat and thumping would budge it. So the job was passed to

Hamble Propellers but despite their expertise it defeated even them. So it was decided to carefully slice the tube near the top and bottom without cutting the stock and then mill down the central section on both sides. To their credit the friendly guys at Hamble Propellers remained good humoured throughout this time consuming job, refusing additional payment beyond the modest quote they had given for the job at the outset.

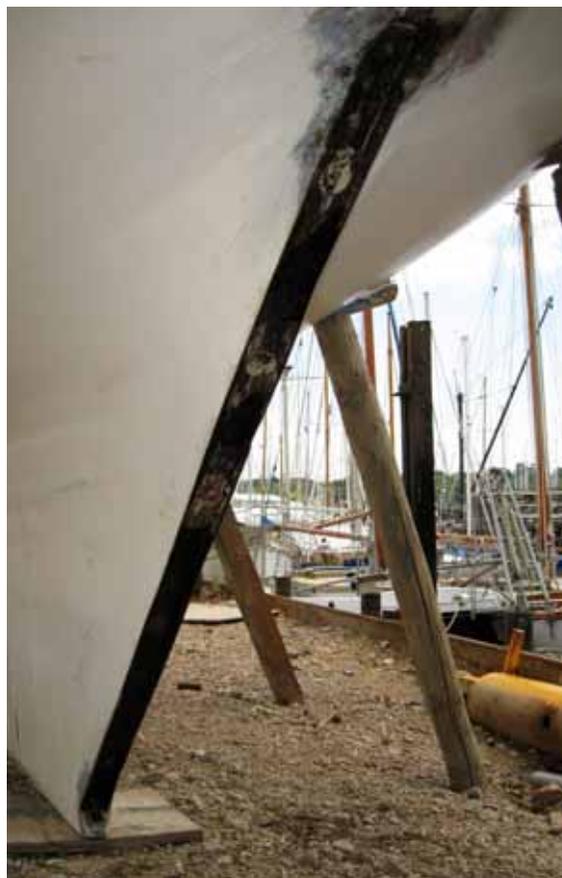
So with the rudder tube returned to me in four pieces the next quandary was how to make good the repair, and try and work out what had caused the problem in the first place. Most baffling was that having had the stock out in 1988 and re-assembled it with copious amounts of Keenol grease why had it seized, considering the same parts had lived harmoniously together for the first sixty-two years of the boat's life.

Had there been no grease at all when first assembled in 1926, or is corrosion more rife in the Solent than in the Channel Islands, or East Anglia? Needless to say there was some debate on what to do this time round, and having assembled the brains trust of professionals and classic boat owners at the Elephant Boatyard, the decision was made to use clear waterproof silicon grease.

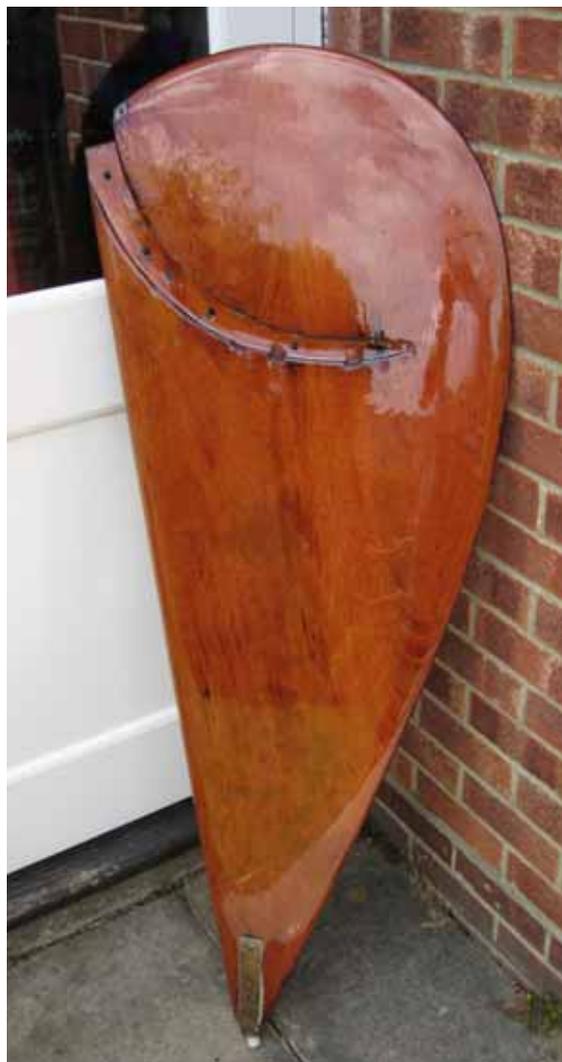
The last bit of the jigsaw to solve was the rudder tube, now in bits, and as would be expected my initial preference was to return the whole job to authentic original specification. But having sourced

1.25" diameter 1/8th wall brass tube not only was the price unenticing (a metre length would be £50 plus carriage) the ends would also need parting off and threading. Time was up so the solution chosen

was to re-use the original undamaged rudder tube ends and bridge the gap with a flexible reinforced plastic pipe, thus using most of the original bits.

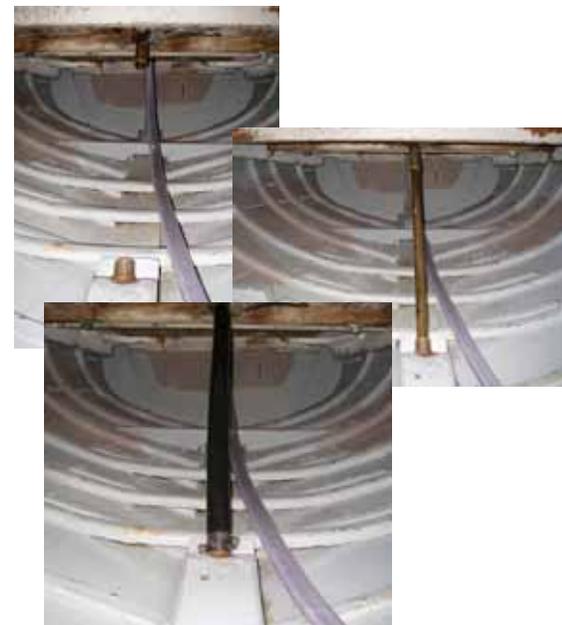
As the bronze stock was slid back up the now two-part tube it occurred to me that yet another job should have been tackled. The very top of the bronze stock had sheared off about five years ago, much to my horror. The same old brass tiller nut had been tightened up on so many occasions, and in my time Loctite has been applied to improve things. At the end of the season I failed to use some heat before applying the socket wrench and off came the 5/8" threaded end complete with nut.

Having chastised myself over the winter months I finally concocted a plan of action. This involved building a timber jig to allow me to accurately drill a hole down the centreline of the stump, which was then tapped with an M6 thread.

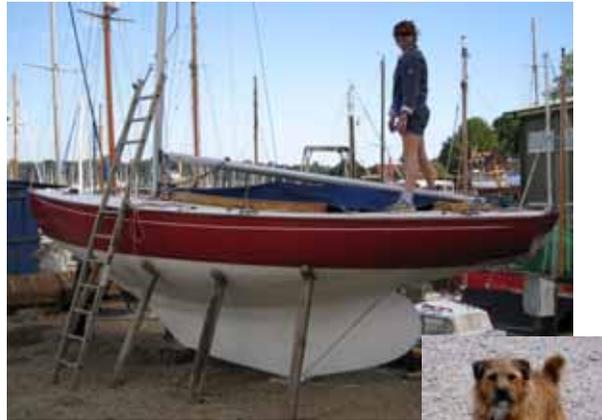
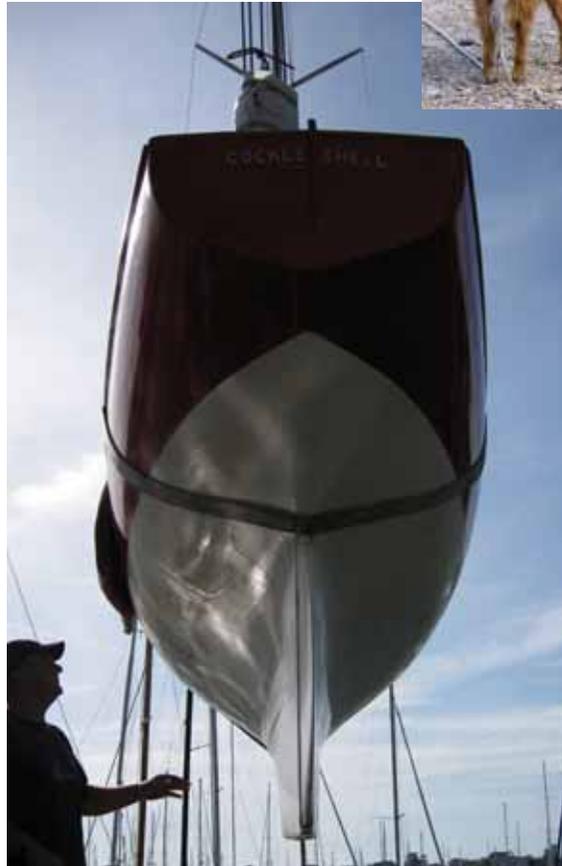
With the two part rudder tube now sealed in place and all the parts offered up it was time for final reassembly.

Some 8mm copper rod had been found in the Elephant shed to make up new rudder rivets, and with generous amounts of Sikkaflex to seal the rudder they were peened over. After a days curing polyester filler completed the fairing, followed by coats of metallic primer and white antifoul.
